ATF Fire Research Laboratory

SUBJECT: FDS Modeling Analysis
30 Dowling Circle

INTRODUCTION:

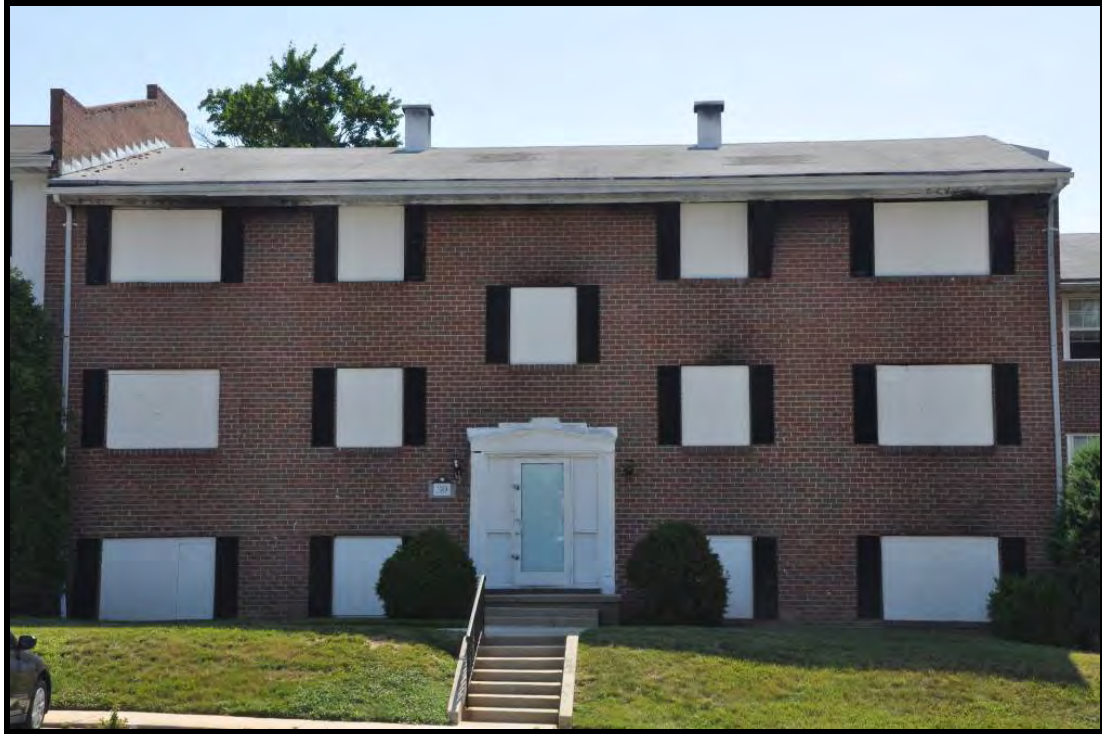
Figure 1. A front view of 30 Dowling Circle.

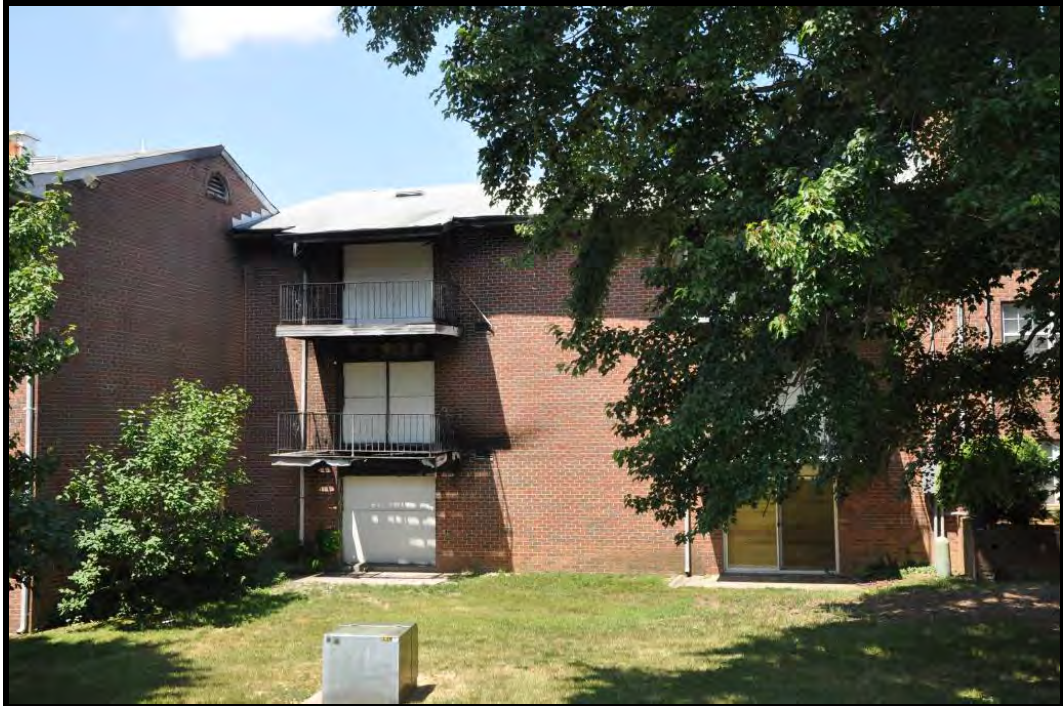
Figure 3. A rear view of 30 Dowling Circle.

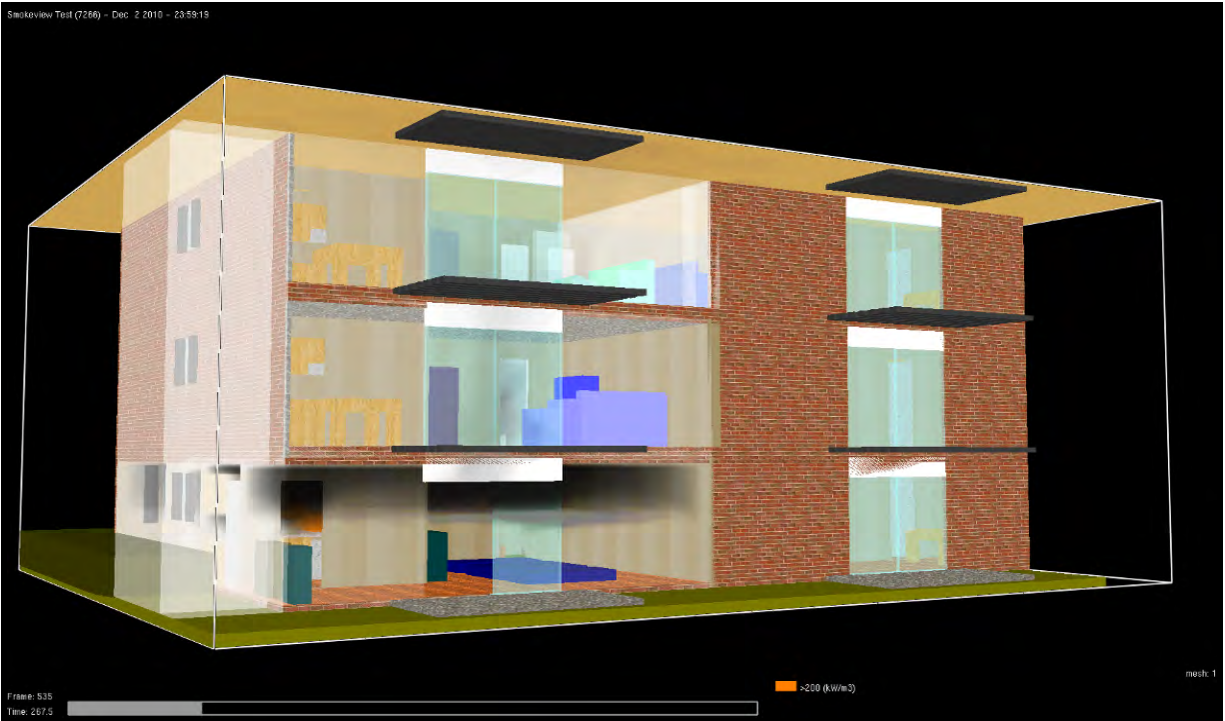
Figure 7. Smokeview frame of the rear of the building indicating the fire origin and smoke spread within the T2 apartment.

The fire originated on the stovetop of an occupied apartment on the right (south) side of the terrace level (apartment T2). Flames from a grease fire ignited kitchen cabinets, eventually causing the kitchen to flashover into the attached living room. Upon fire department arrival, a fully developed fire existed in the living room and kitchen of apartment T2. Prior to exiting the apartment, the occupant opened both the rear sliding door and the apartment entrance door in an attempt to ventilate smoke from the apartment. These openings provided sufficient ventilation and supported rapid fire growth within the apartment.

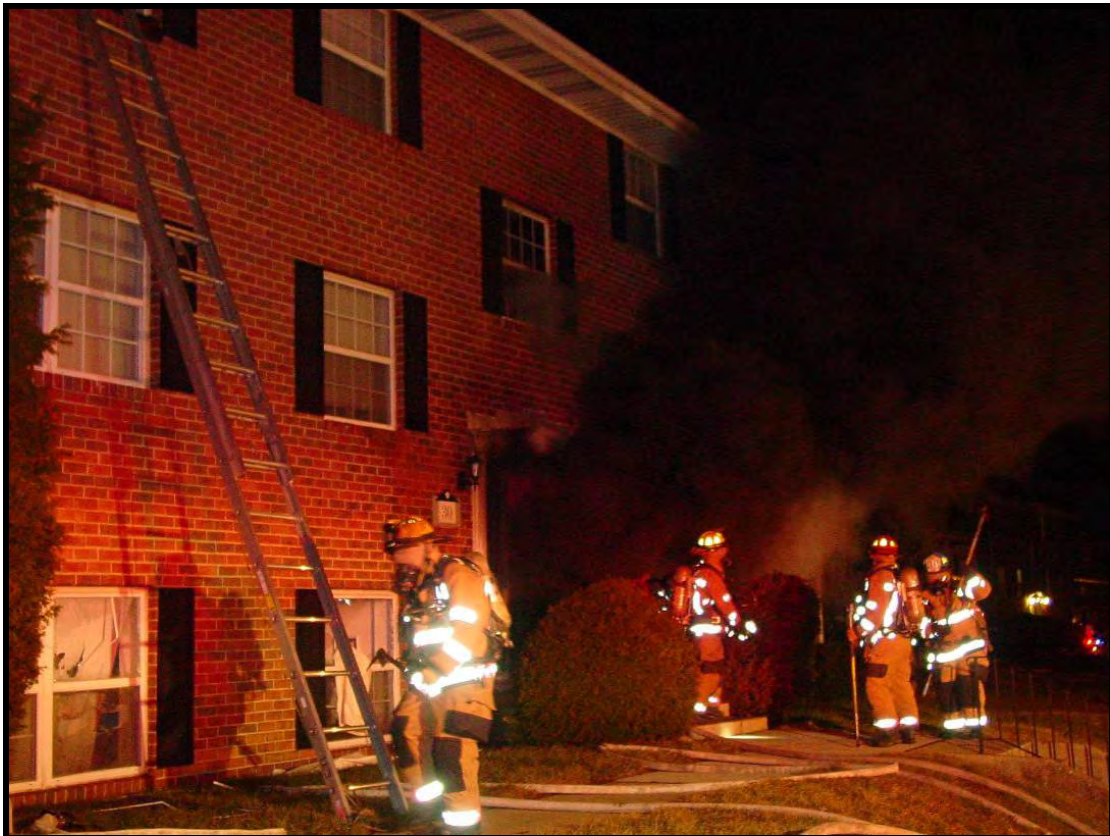
Figure 14. Front photo of unidirectional flow of smoke up stairwell from apartment T2. Note the high volume of smoke from floor to ceiling as the stairwell door serves as the flow path outlet. The

ground ladder in the foreground was used to rescue an occupant on the third floor trapped by heavy smoke in the stairwell.

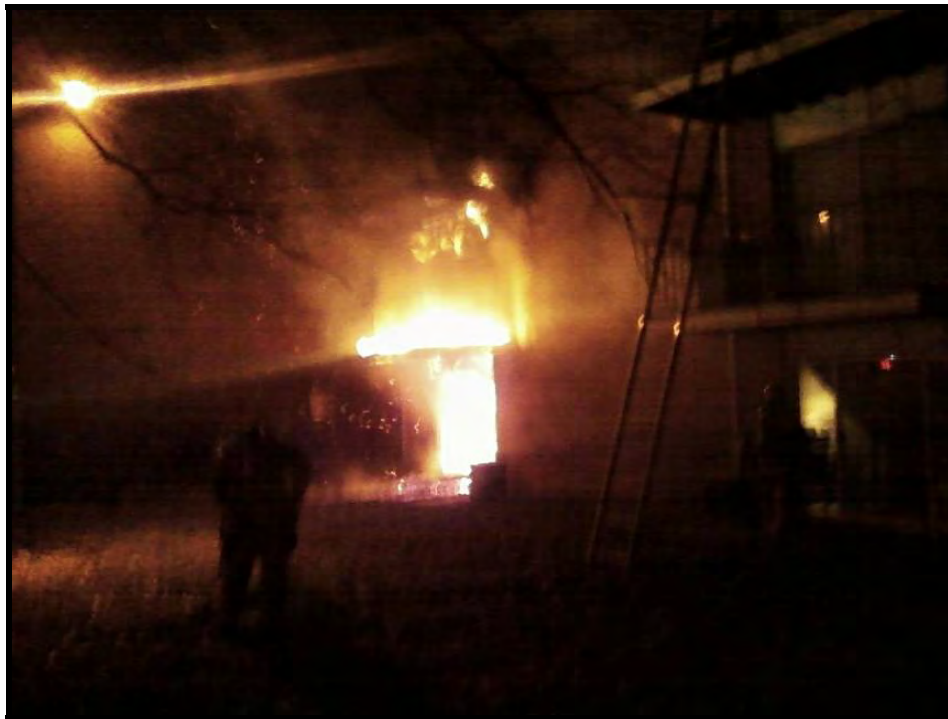
Figure 15. Photo from rear of flames in apartment T2 and extension to the balcony above. Note the relative minimal volume of smoke as the sliding door serves as the inlet for ventilation into the apartment. The smoke and heat is flowing in from the rear, through the apartment and up the stairs.

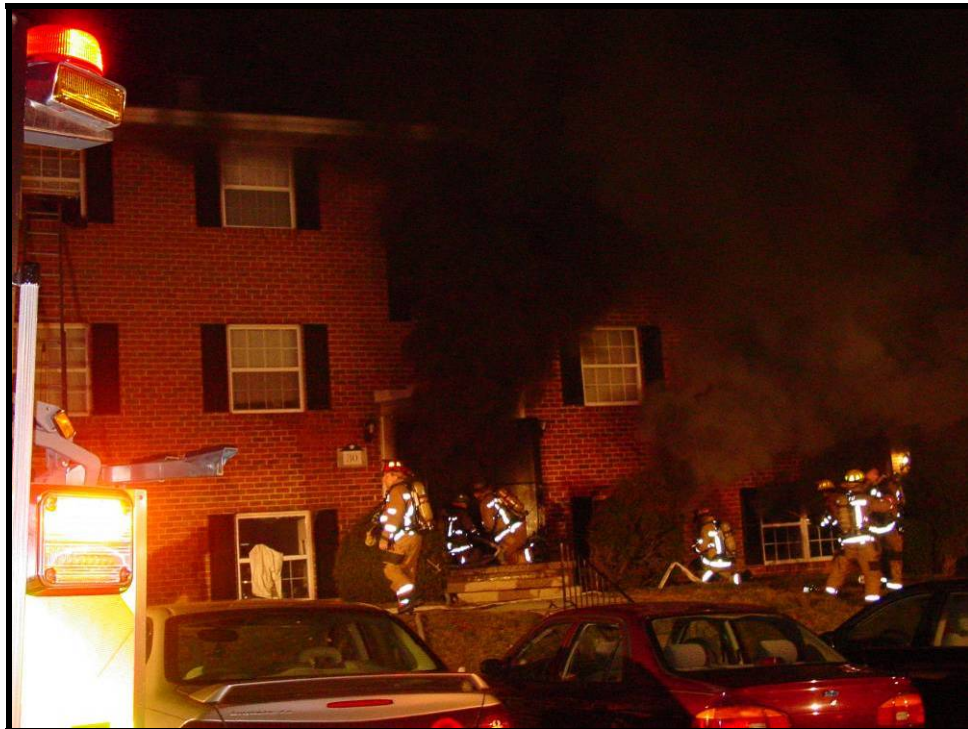
Figure 17. Photograph of hoselines being positioned at the stairwell entrance door and front window. Note the heavy smoke venting from all front openings in apartment T2.

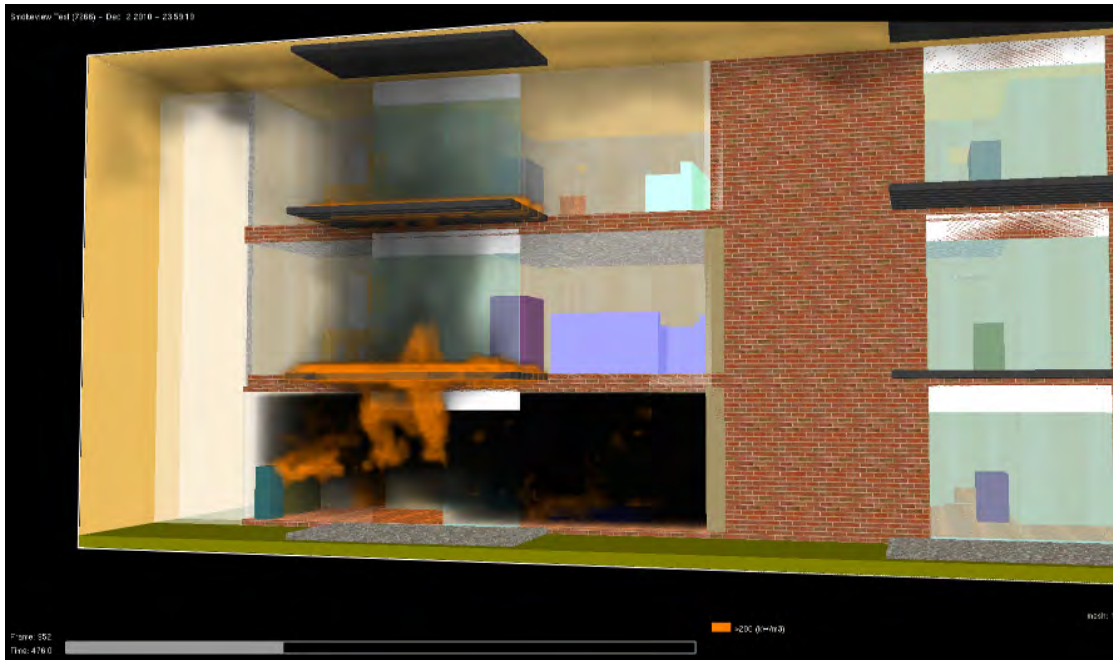
Figure 18. Smokeview frame of the rear of the building with flames extending from T2 and involving both balconies above.

Flames extended upwards from the T2 apartment sliding door and ignited the rear balconies of the second and third level apartments above. Fire on the second floor balcony extended into apartment A2 by failing the sliding glass door and igniting vertical plastic slat curtains that were suspended above. As crews searched within the second floor apartment, they noted seeing the burning curtains on the floor with flames extending to a nearby couch (containing polyurethane foam padding) adjacent to the sliding doorway. The fire continued to grow un-suppressed and spread to a second couch as interior firefighting crews were engaged in rescuing two victims from the living room in the second floor apartment.

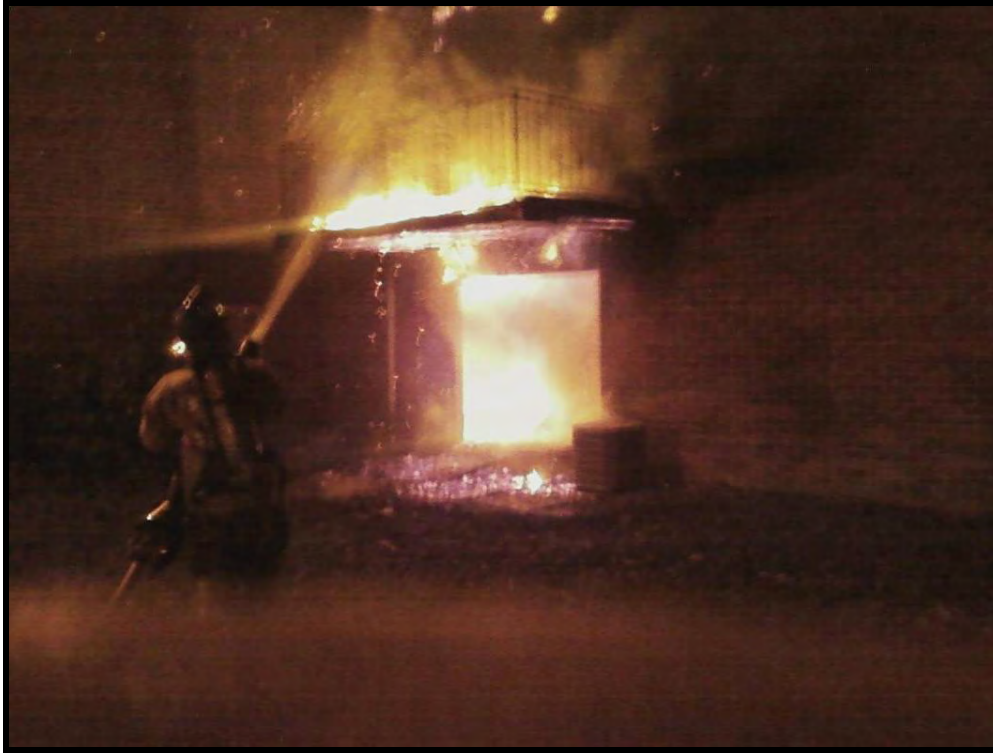
Figure 19. Photo of flame extension and suppression efforts at the rear of the structure. Flames caused the second level glass slider to fail and ignite plastic curtains in the doorway located at the top of the photo.

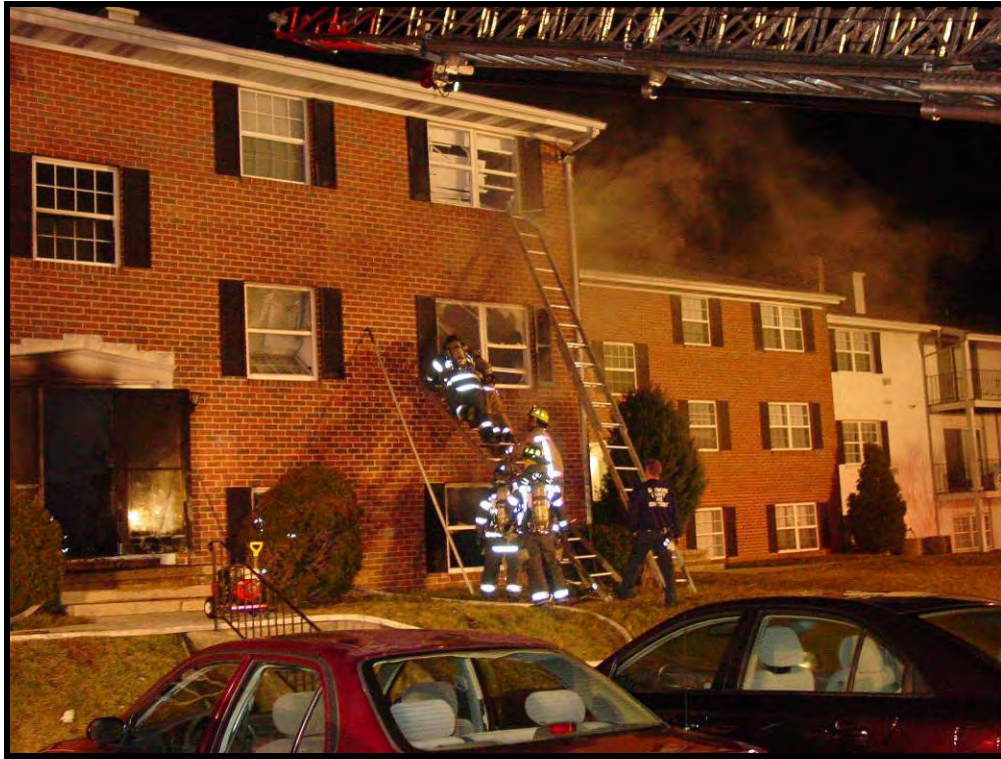
Figure 22. Photo depicting building smoke and fire conditions around the arrival of Squad 303. Note the lack of heavy smoke or fire in the stairwell or terrace level. There is also no indication of the growing fire in the second (middle) level apartment.

Squad 303's crew arrived on scene after the bulk of the fire in the terrace level apartment had been suppressed and appeared to be under control. The crew entered the front stairwell, which had minimal smoke up to the second level and the crew began to systematically search the building.

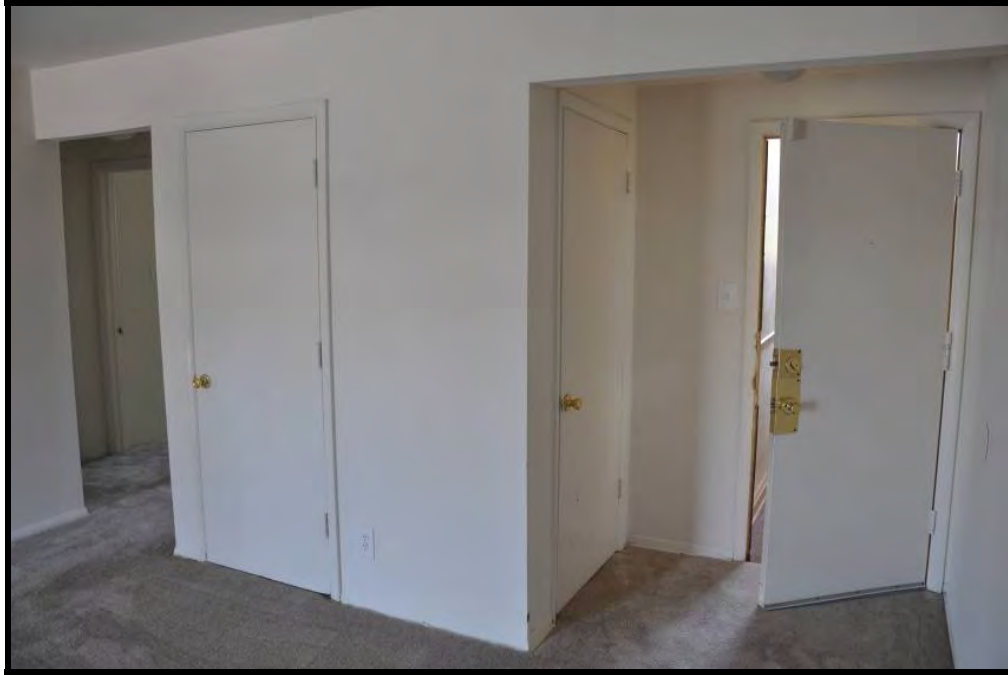
Figure 23. Exemplar apartment showing apartment entrance door.

Squad 303's crew proceeded to search two apartments before entering the third floor right side apartment to conduct a search, leaving the entrance door open. It should also be noted that carpeting impacted the bottom of the door and prevented the apartment entrance doors on the second and third levels from closing automatically. The entry doors had to be actively pushed closed to overcome the friction of the carpet.

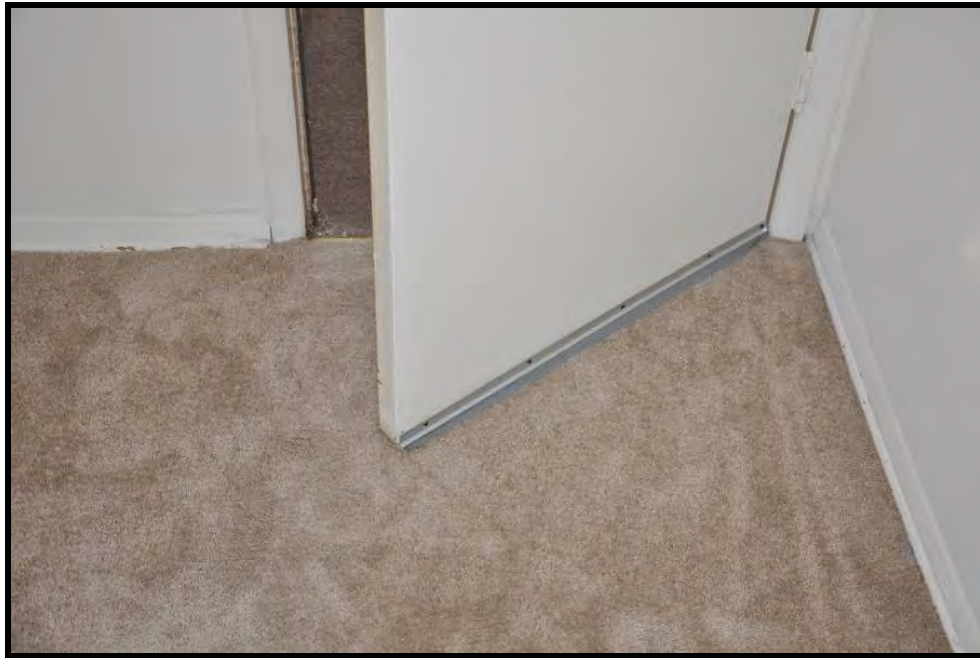
Figure 24. Close view of base of the door impacting the carpet, preventing the door from self closing.

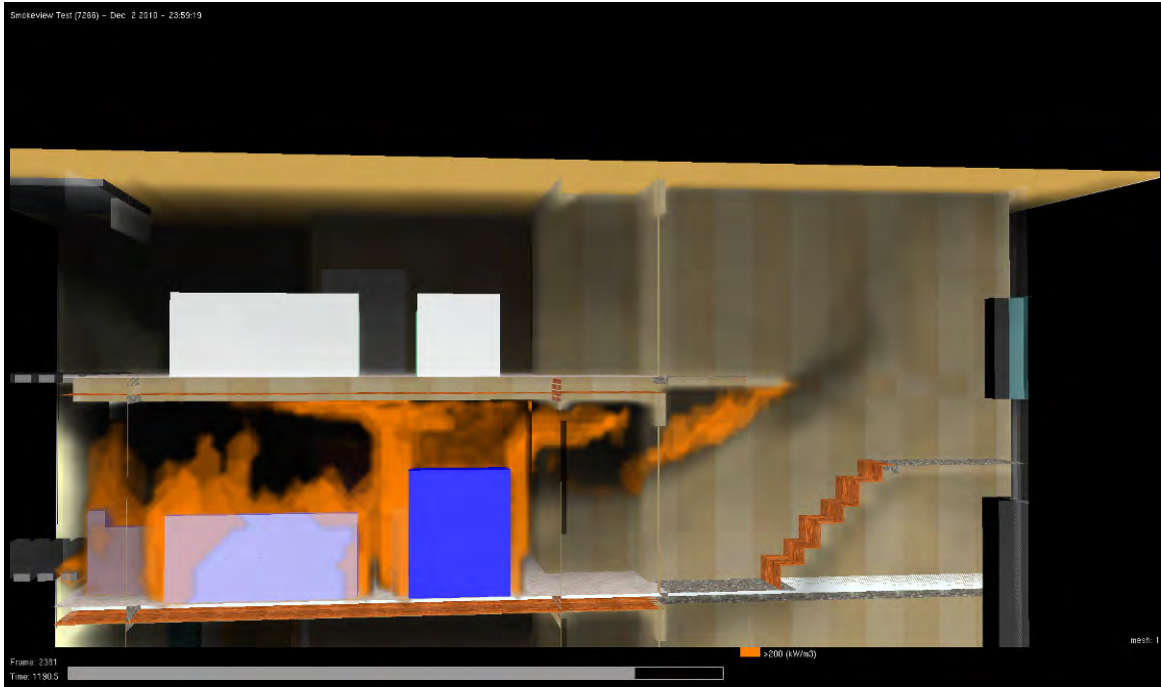
Figure 28. Rollover from the second level apartment into the stairwell. The second victim was removed from the apartment just as flames began to extend out of the door. Firefighters covered the victim to protect her from the flames, sustaining damage to their gear.

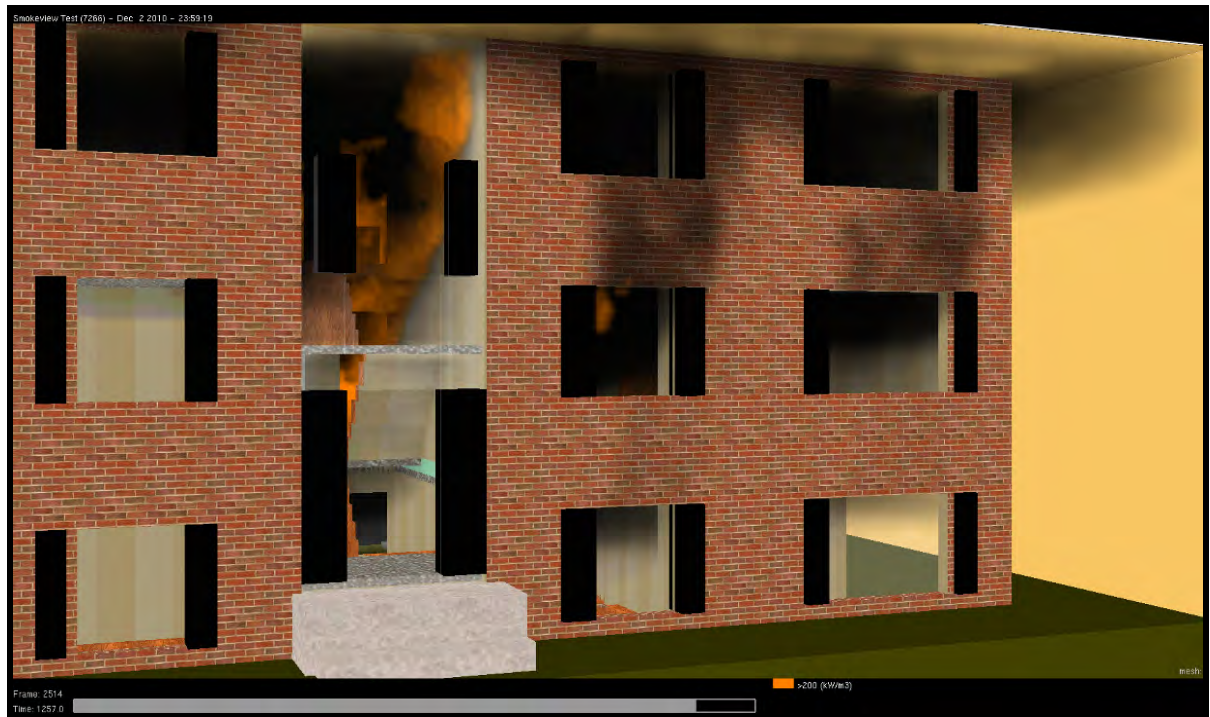
Figure 35. A front view of the apartment building from Smokeview of flames extending through the stairwell into the third floor (front stair wall is hidden to show flame extension).

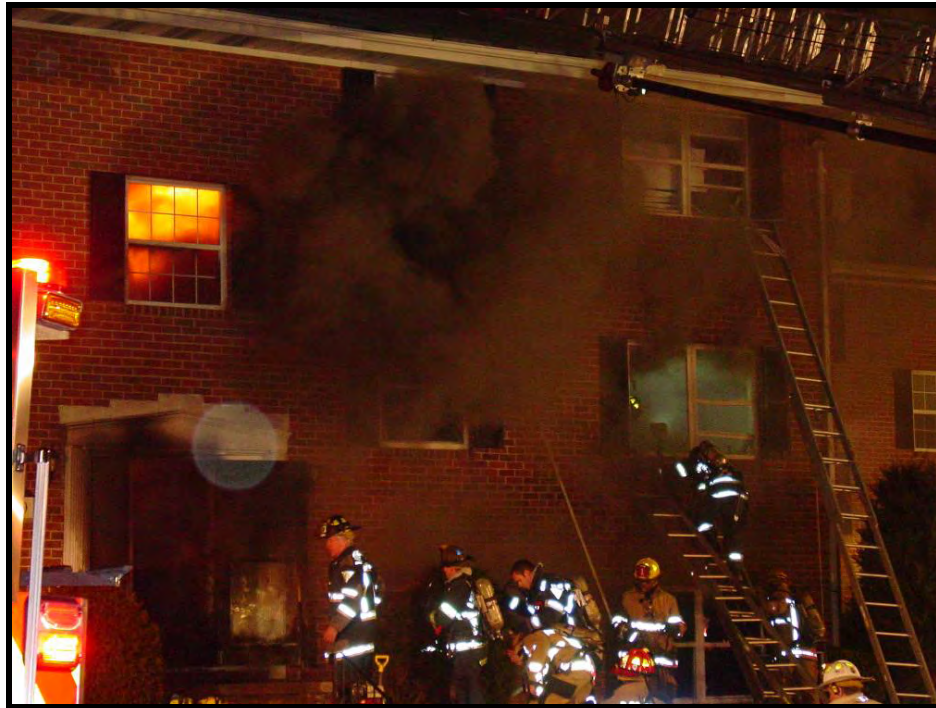
Figure 36. Photo showing flame extension into hallway as the second floor apartment reaches flashover. Note the heavy smoke and fire conditions that now exist in the stairwell as compared to when Squad 303 originally made entry.

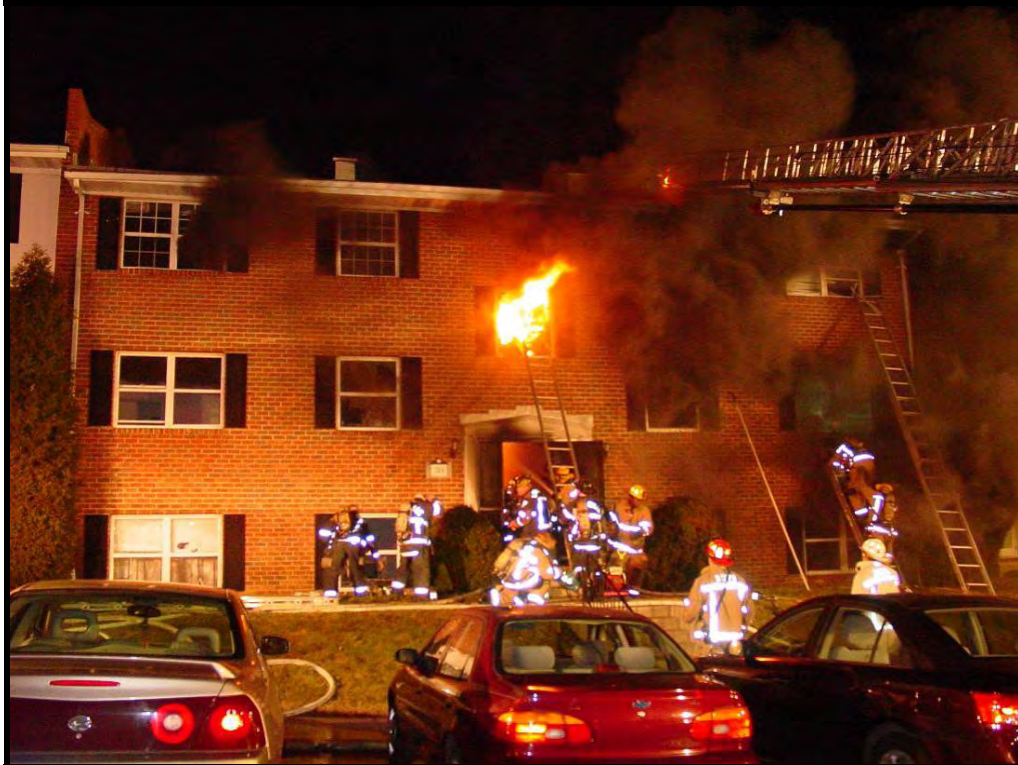
Figure 37. Photo showing flame extension through the stairwell to the third level. The stairwell window is broken by a ladder just after flames extend to the third floor. Evacuation tones are sounded just before this photo.

Command sounded the building evacuation tones as flames extended into the hallway and up to the third level apartment. Two couches just inside the entrance door on the third level ignited, blocking the primary means of egress for both firefighters from Squad 303.

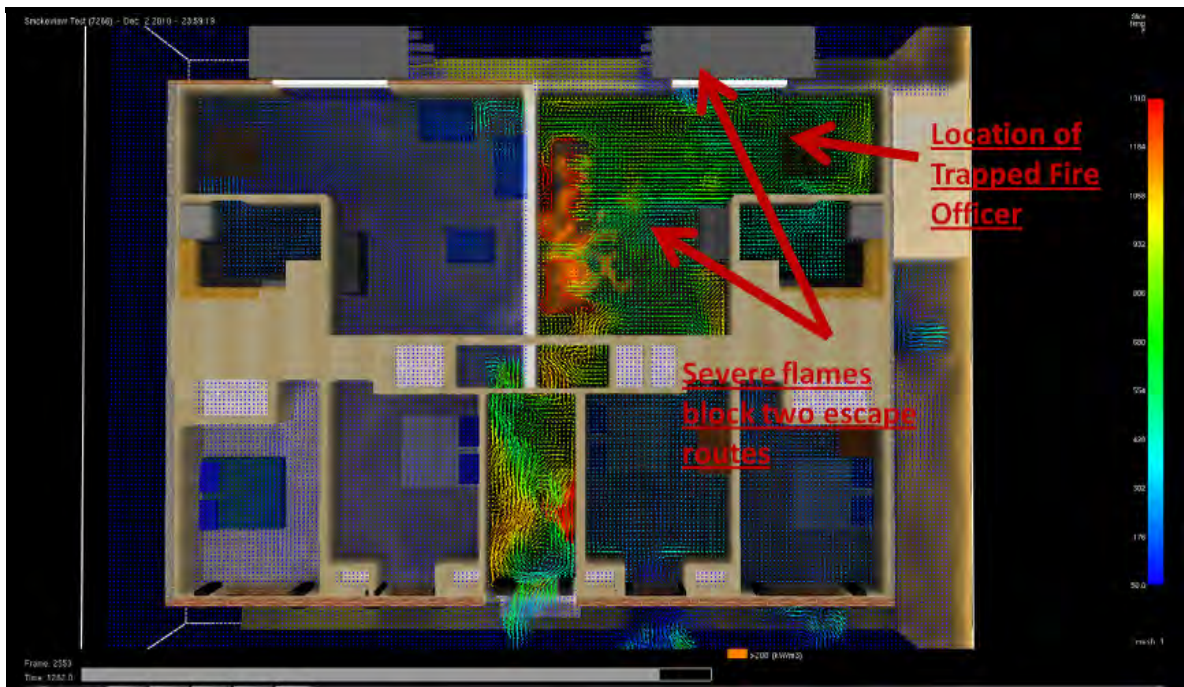
Figure 38. Plan view showing location of trapped fire officer and potential escape routes through structure, both of which are block by flames.

Upon hearing the evacuation horns from the trucks, the second firefighter from Squad 303 (searching the front bedrooms) attempted to exit the apartment via the apartment entrance door, however he was blocked by flames in the living room and stairwell. Trapped in the bedroom, the firefighter bailed out headfirst down a ground ladder on the front side from the third floor.

Squad 303 officer's means of egress through the apartment entrance door was also blocked by the flames in the living room and stairwell. There were no windows located in the rear of the apartment. The only means of escape was the balcony slider, however the entire balcony was engulfed in flames from the fully involved apartment below.

With both escape routes blocked by flames and experiencing extremely high heat conditions, Squad 303's officer requested assistance and declared a MAYDAY from the rear of the third floor apartment. Firefighters re-entered the structure to combat the fire and locate the trapped firefighter. The downed firefighter was eventually located on the third level just inside the sliding glass door and was removed to the rear balcony. The firefighter was then extricated in a stokes rescue basket down the aerial ladder of a truck located in the rear, where he was subsequently transported to the hospital.

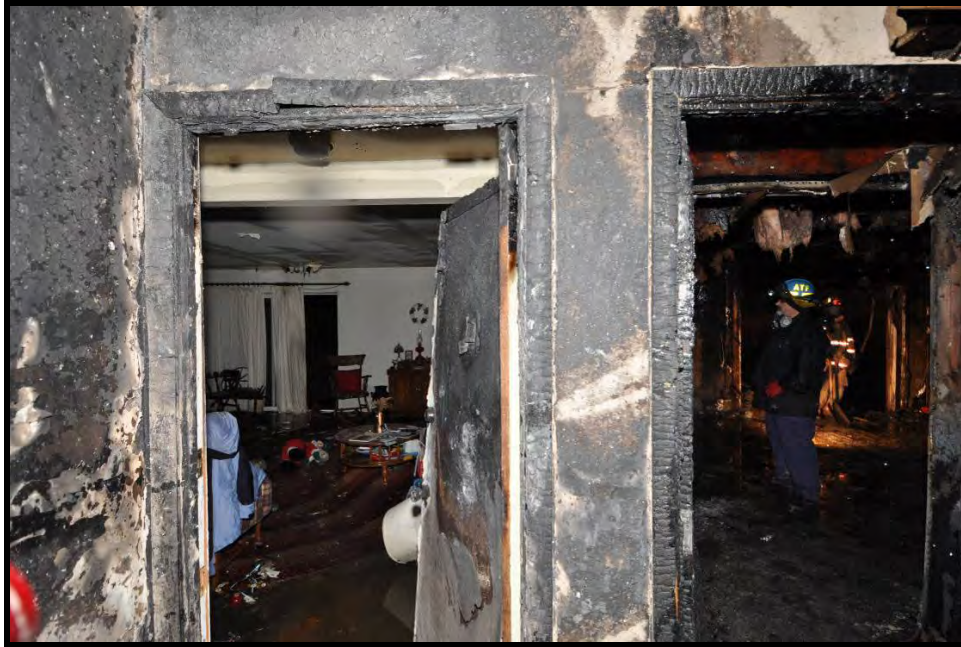
Figure 48. Terrace level stairwell landing looking into T1 (left) and T2 (right) apartments.

The impact of compartmentation on fire and smoke spread is evident by examining the post-fire damage throughout the structure. While other factors contributed to the relative fire damage, including fire department overhaul and relative apartment configuration, analyzing the damage to the building and the position of the apartment entry doors provides insight on the benefits of compartmentation. By closing apartment unit entrance doors and interior hollow core doors, one can slow or even block the ventilation flow path through the structure, thus significantly reducing the rate of fire spread. The photos below represent the post-fire damage in all six apartments within the fire building. Four of the six apartment entry doors were open for the majority of the fire and the relative difference in damage is clearly evident.

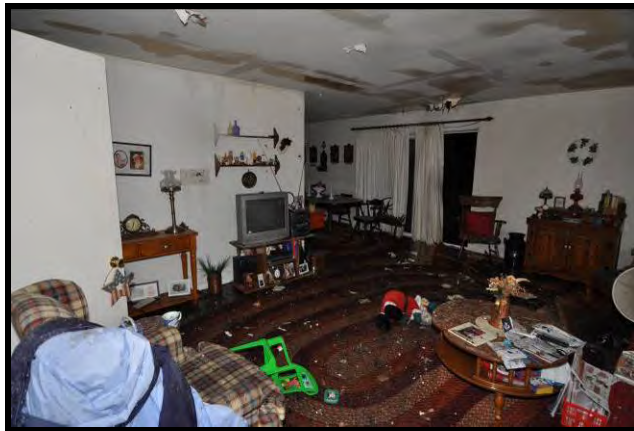
Figure 49. Damage to apartment T1. Door was closed for majority of the fire.

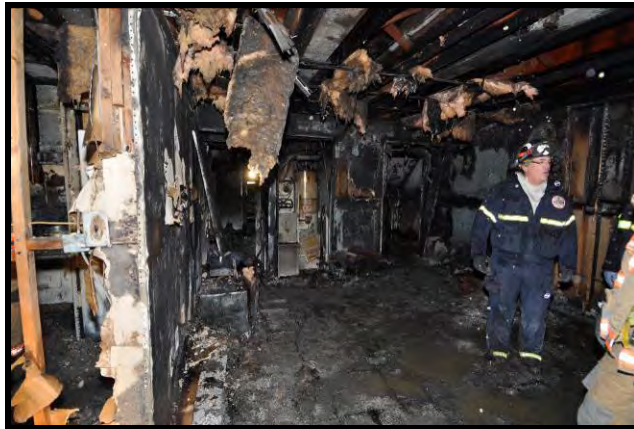
Figure 50. Damage to apartment T2 (post overhaul). Door was opened by occupant after discovering the fire.

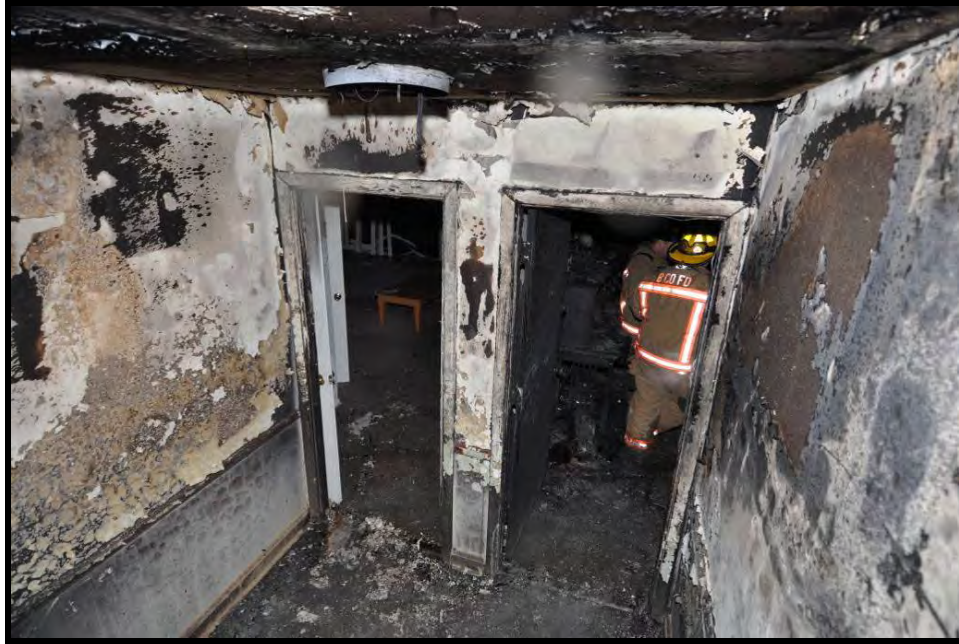
Figure 51. Photo of second floor stairwell landing and apartments A1 (left) and A2 (right).

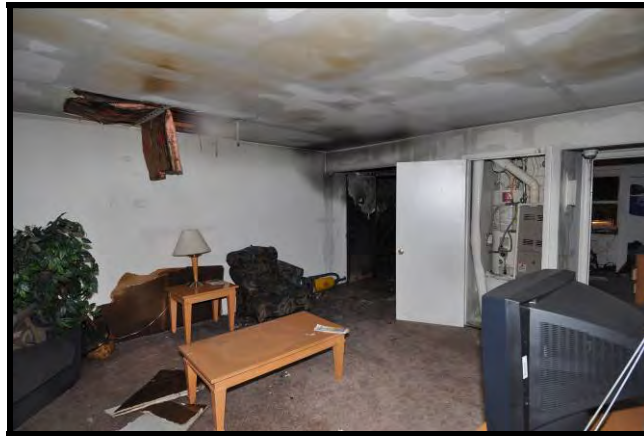
Figure 52. Photo of damage to apartment A1. Door was closed for majority of fire.

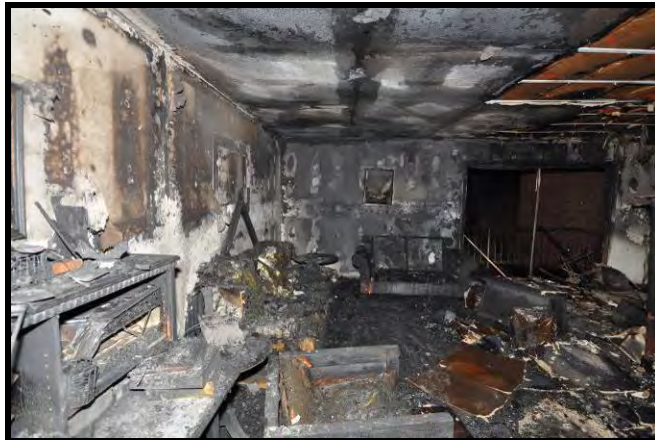
Figure 53. Photo of damage to apartment A2. Door was left opened by search crews.

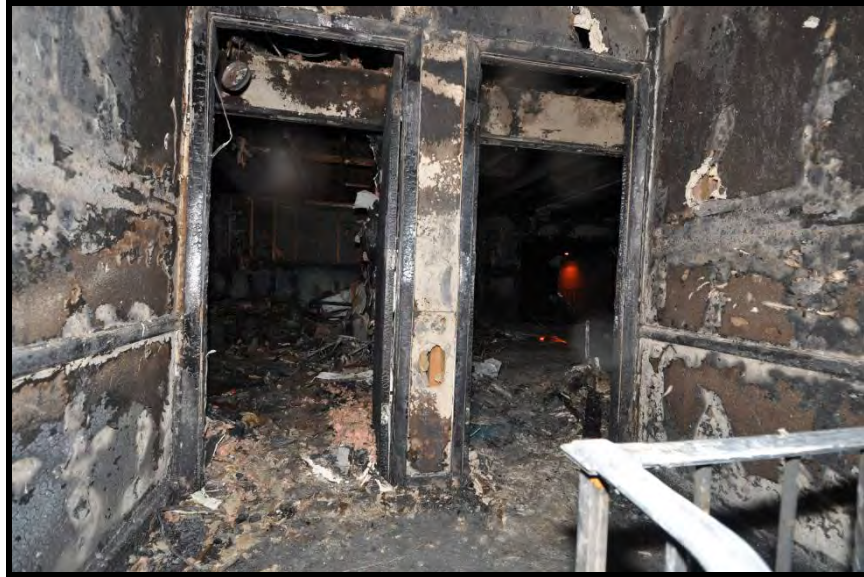
Figure 54. View of the third floor landing looking in at apartments B1 (left) and B2 (right).

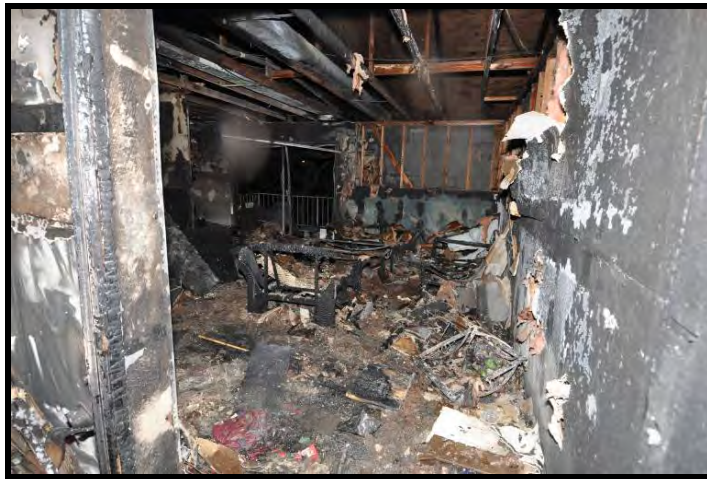
Figure 55. Damage to apartment B1 (post overhaul). Door was left opened by search crews.

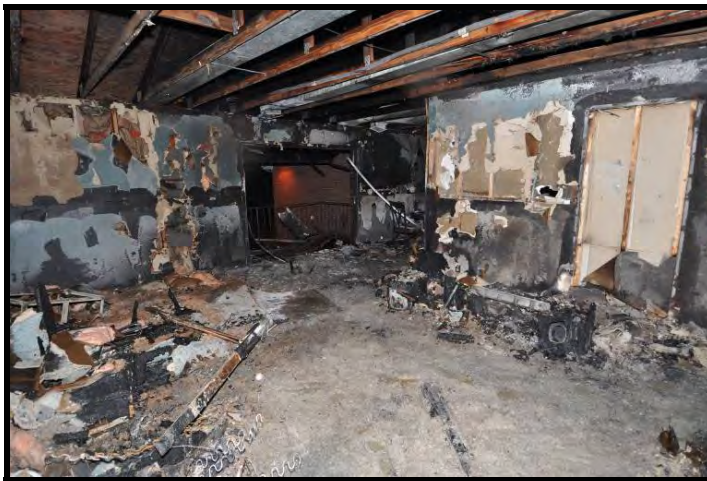
Figure 56. Damage to apartment B2 (post overhaul). Door was left opened by search crews.

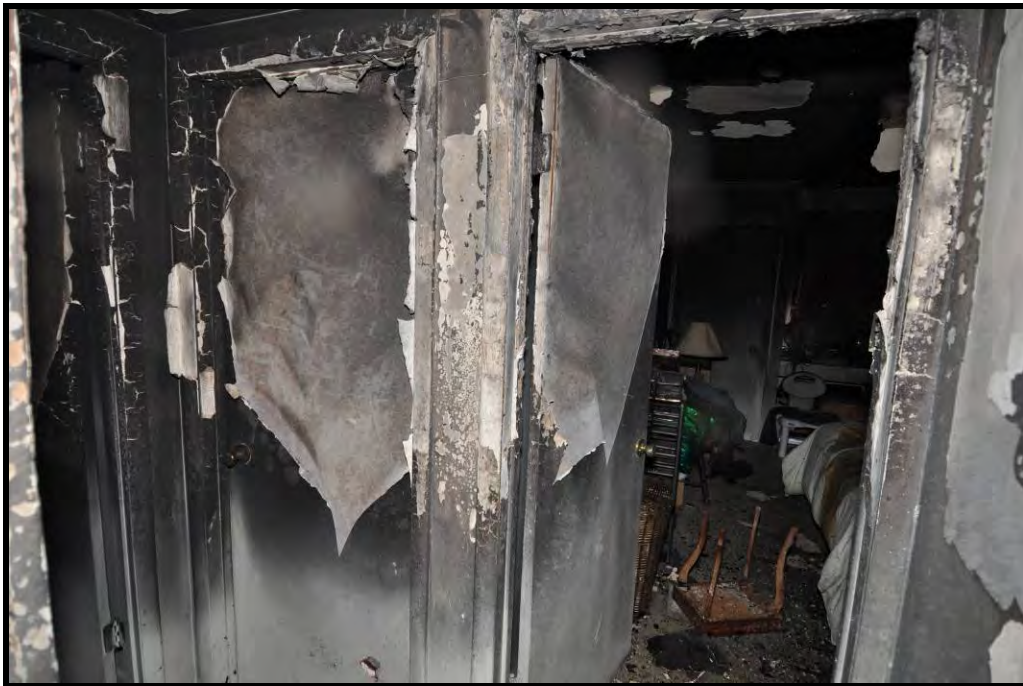
Figure 57. The left side hollow core door in this photo was shut by search crews after removing a victim from the living room to the bedroom. The living room reached flashover a short time later.

Using doors to compartmentalize and limit fire and smoke spread in a structure is not limited to fire-rated entrance doors. Interior hollow core doors also offer considerable protection for compartmentation purposes. A search crew utilizing the Vent, Enter and Search (VES) technique through a front window used a hollow core bedroom door to isolate themselves from the developing fire in the living room of apartment A2. As the crews removed the second victim from the living room to the bedroom, they shut the bedroom hollow core door behind them. The living room soon experienced flashover followed by full room involvement, however the bedroom remained isolated from the heat and smoke for the duration of the fire. The photos below illustrate this effective use of compartmentation to protect firefighters during a search.

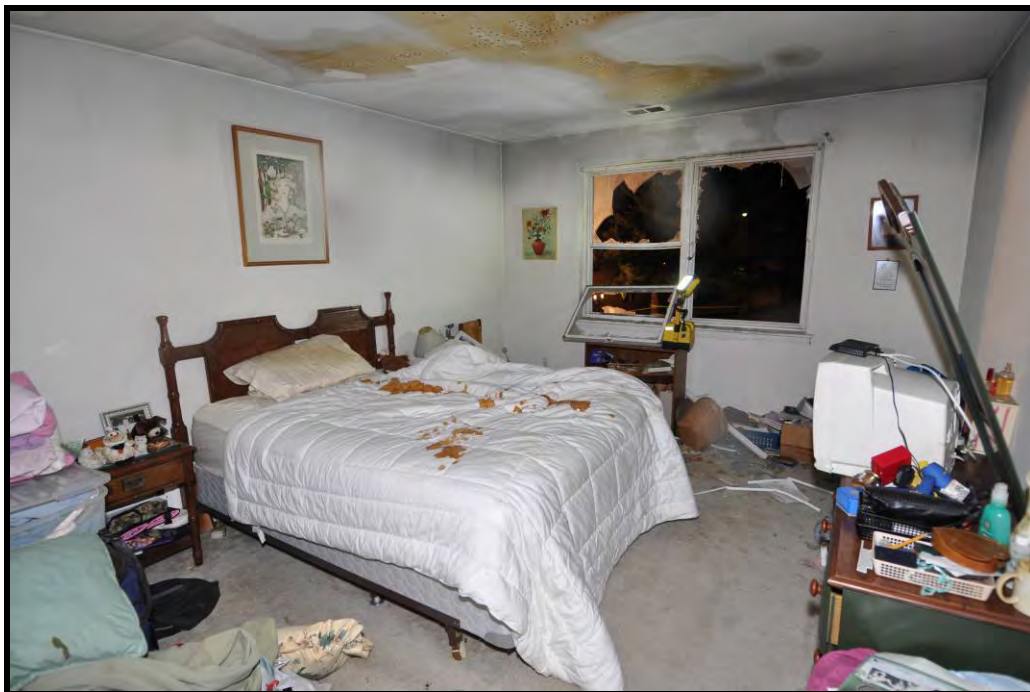
Figure 59. A second photo of same bedroom showing the VES window where the search crew entered and exited the apartment. Taking the time to shut the hollow core door blocked the ventilation flow path through the front window, thus isolating the crew and victim from the severe smoke and fire conditions in the hallway and living room.

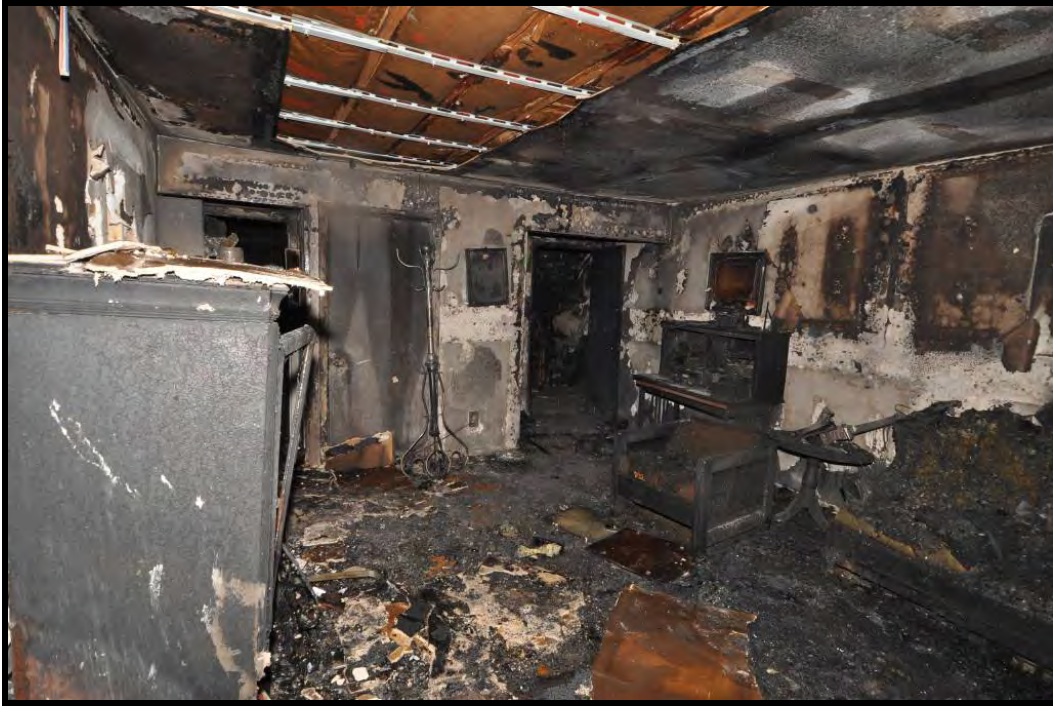
Figure 60. Photo of living room that experienced flashover in apartment A2. The hollow core bedroom door is located in the small hallway at the upper left of this photo.
